1995 54' Mediterranean Sportfisher 54

Report of Marine Survey for Insurance

George Malhiot, NAMS Associate Marine Surveyor, IIMS, USPAP Compliant Appraiser, ABYC
Ocean Marine Surveyors, Inc © 2024 - All Rights Reserved

Date Of Survey: April 4, 2024

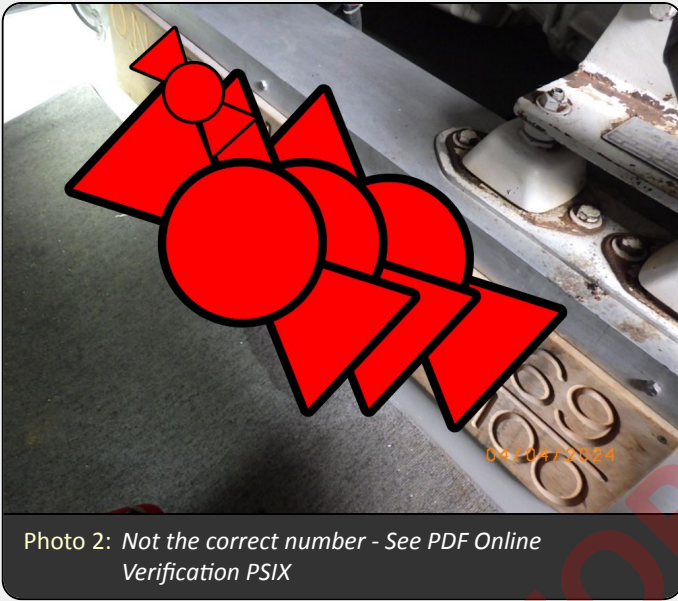
In the USA, the Waters - USCG Documentation number was not observed.

Install the proper - correct number for US Waters

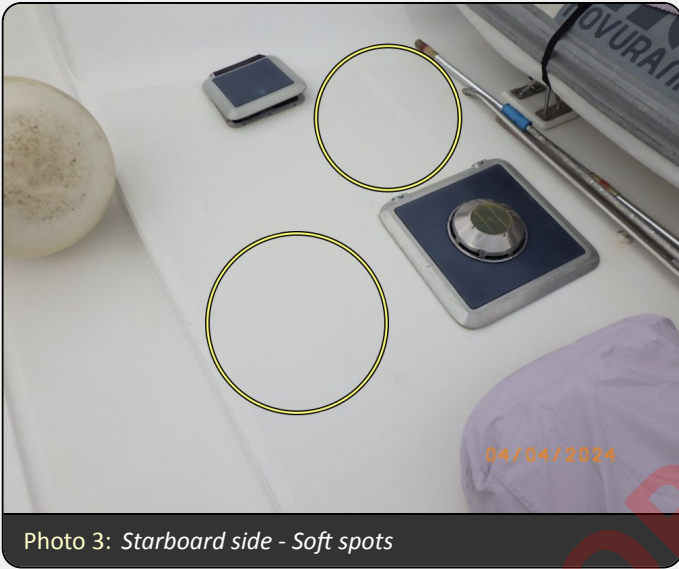
* Forward bow decking between the vent hatch and large hatch - Starboard side - Soft Decking - internal wood decay

Photo 3: Starboard side - Soft spots

Repair in accordance with good marine practice, as necessary.

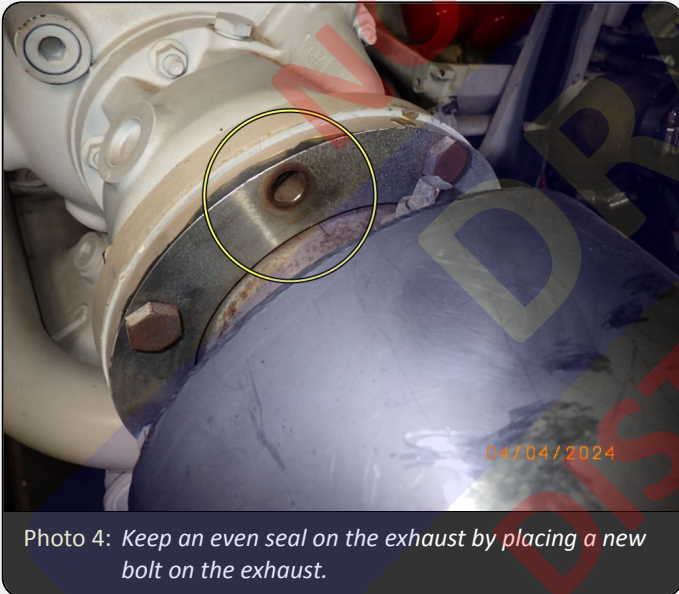
Stbd Side exhaust dump - missing bolt

Photo 4: Keep an even seal on the exhaust by placing a new bolt on the exhaust.

Install proper bolt

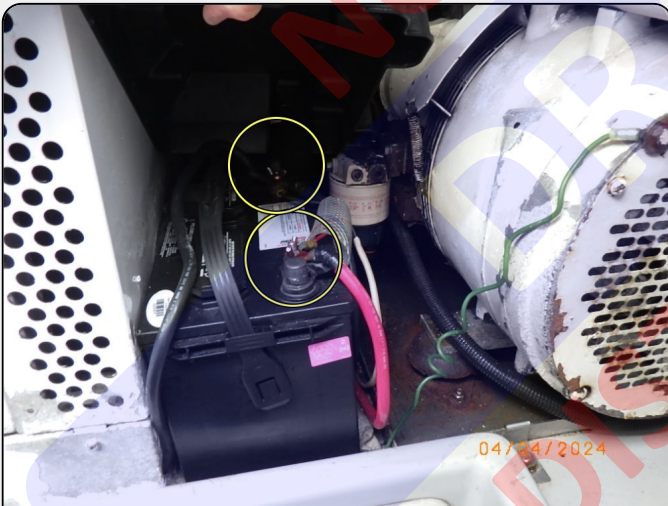
Photo 7

NOTE: IT IS NOT CRITICAL, BUT THEY CAN LOOSEN AND CAUSE ISSUES WHILE UNDER POWER.

Install properly sized hex nuts to secure battery cable conductors.

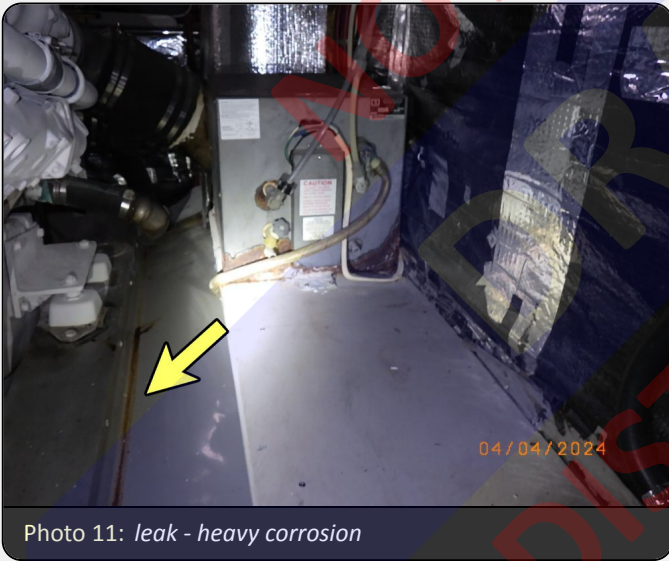
Both water heaters are leaking

Photo 11: leak - heavy corrosion

Replace both water heaters

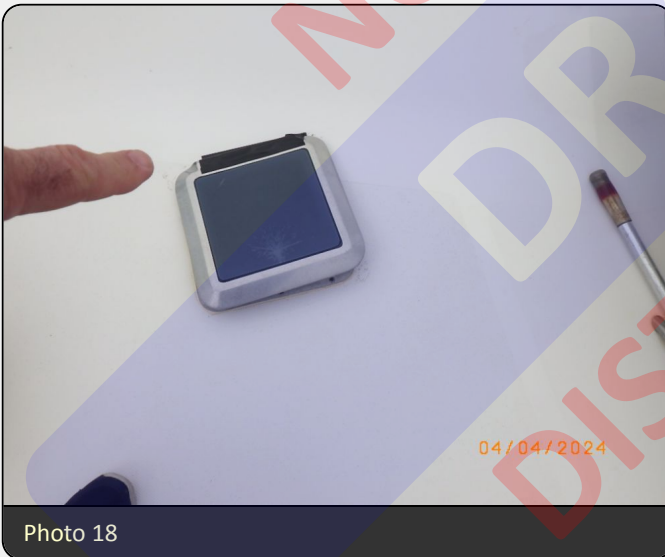
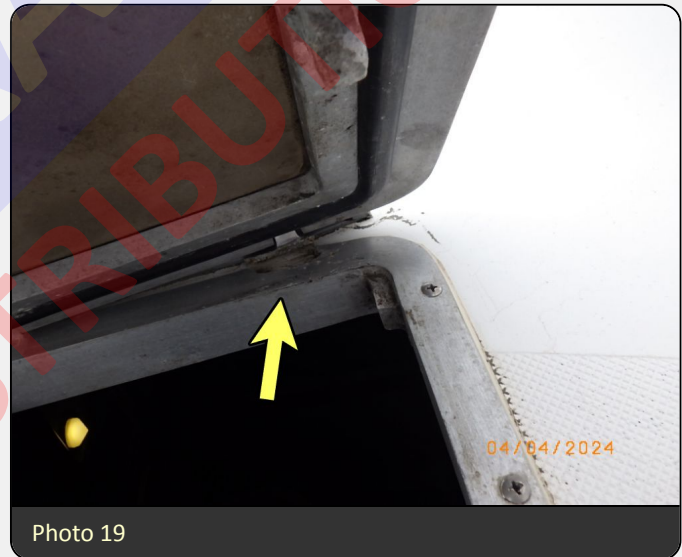
Head Ventilation hatch on the port side was broken

Replace hatch

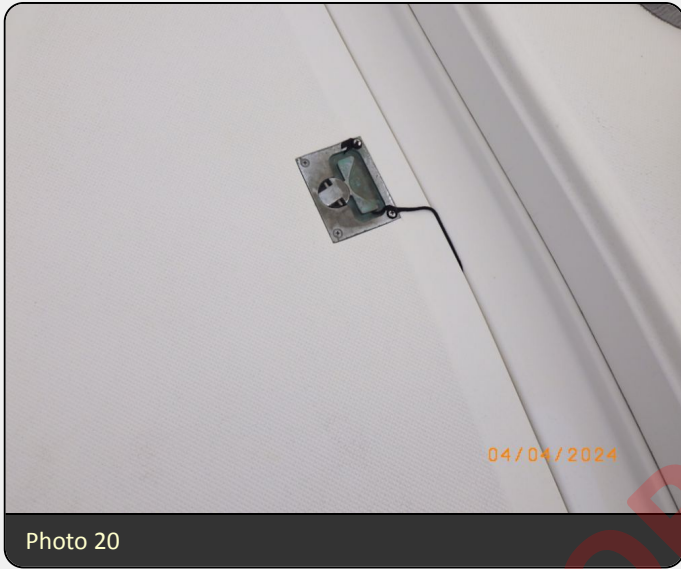
Photo 20

Dog Ear latch was broken to the anchor locker on the port side

Replace latch.
