2005 57' Beneteau 57 Beneteau

"SAMPLE PREPURCHASE SAILBOAT"

Report of Marine Survey

Date Of Survey: March 11, 2024

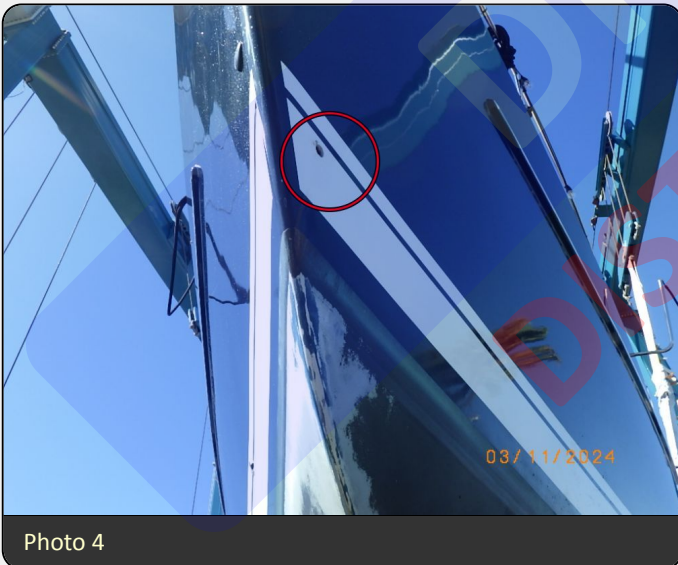
Clam shell missing on the port side of drain may cause water to suck into the bilge while underway.

Install a new clam shell cover to defer water away from the drain.

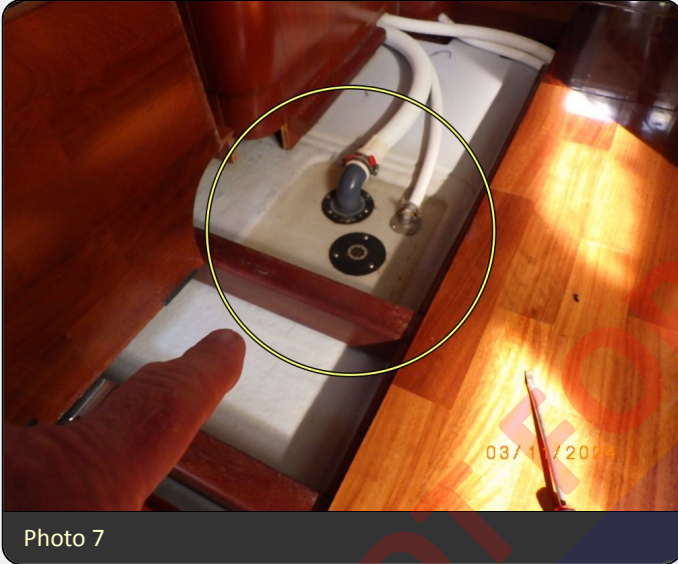
Photo 7

The mast boot appeared to be malformed, and water may be passing through - water was found on the port side, on top of the water tank which could come from the mast.

Investigate further/trace, and address/refinish as necessary.

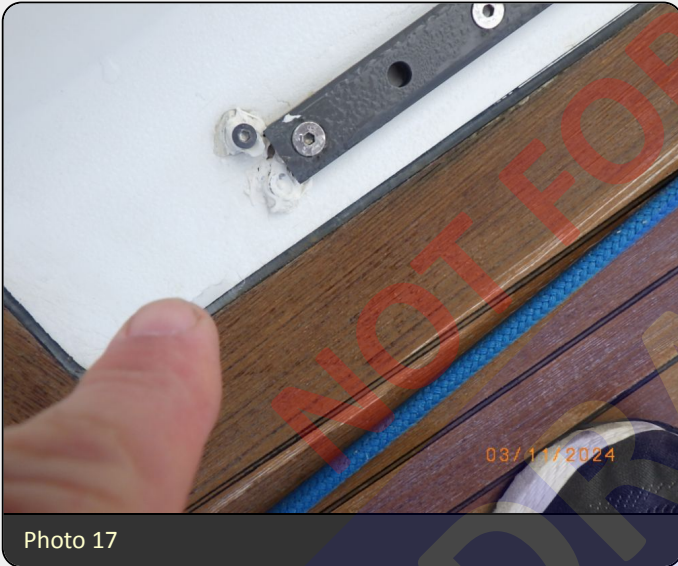
Traveler stops were broken on port and starboard sides.

Renew when possible.

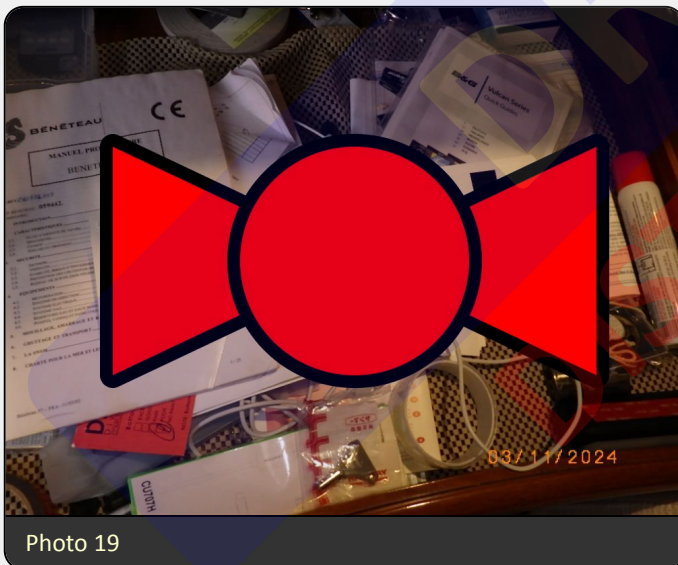
The vessel's U.S.C.G. Documentation Number was not displayed onboard. It was a plate that was loosely stored in the chart table.

Mount onto the vessel.

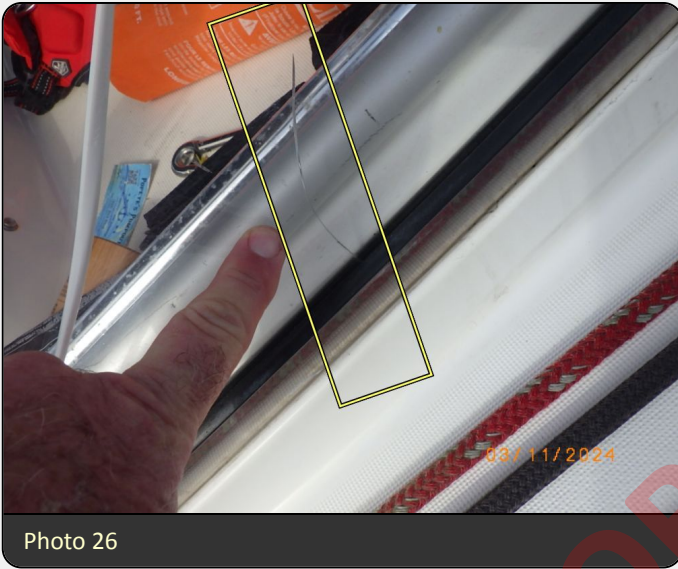
Photo 26

Starboard cockpit window was cracked (plexiglass material)

Replace as desired.
