Pre-Purchase Report of Marine Survey

"SAMPLE PURCHASE POWER BOAT"

2022 72' Riviera Convertible Sport Fisherman 72

Date Of Survey: January 12, 2024

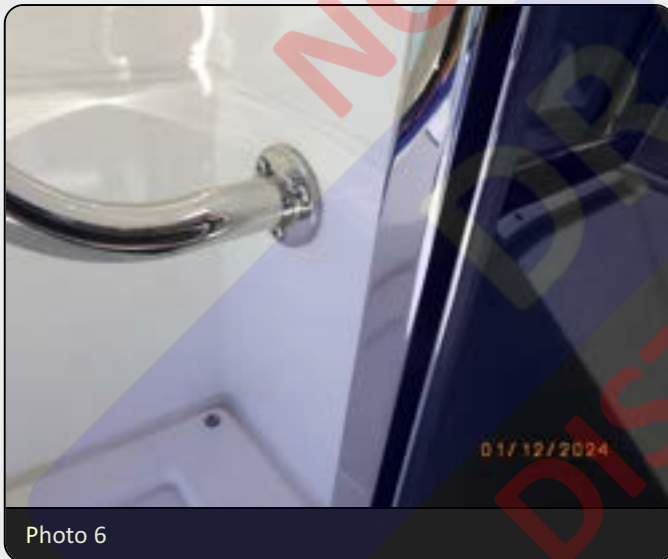
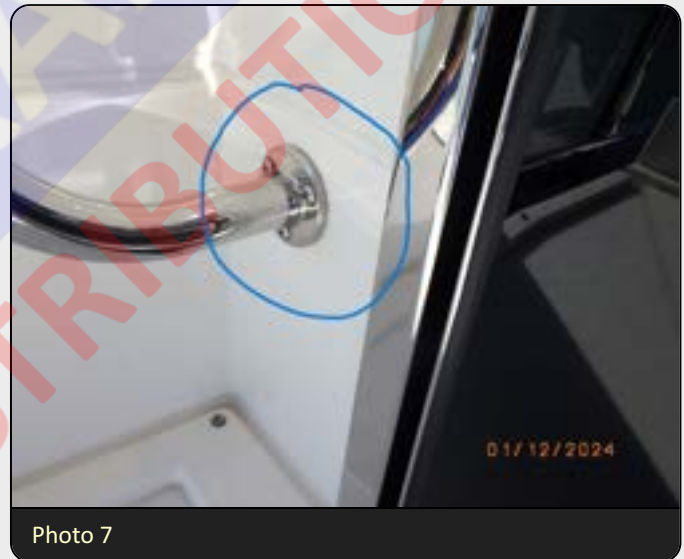
The ladder fasteners were either loose or lack support.

Secure ladder and fastener.

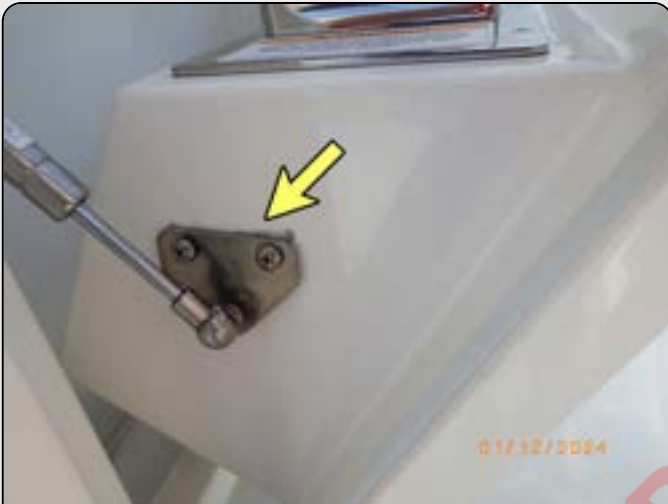
Photo 17

Gas strut fasteners were loose.

Tighten the fastener to secure

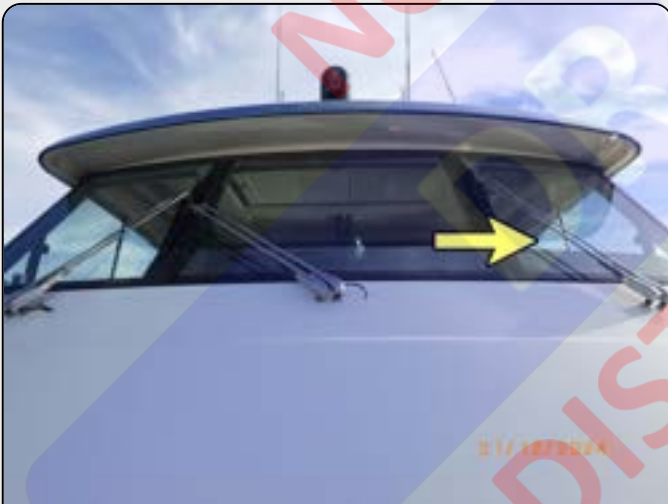
Photo 19

The port washer hose was cut or broken off.
Blades were a season or more old.

Replace with new.
As for maintenance, change blades yearly to prevent etching on the glass when blades degrade.

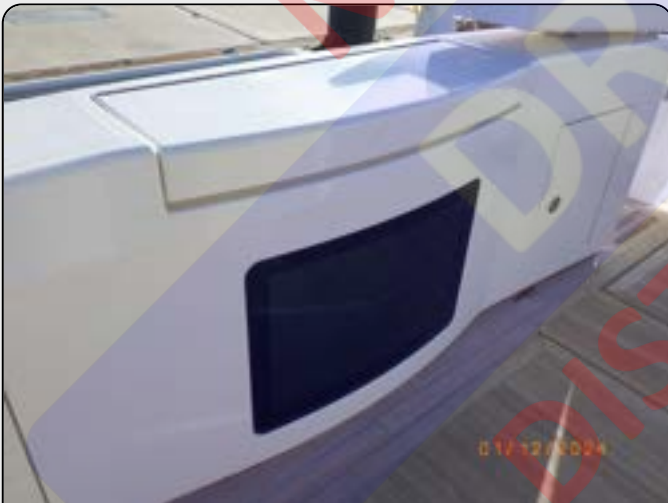
Photo 22

Unknown leak of water from the port center side of the tank - Possibly the seal inside the tank.
Water leaked on the electricals in the aft bilge

Rinse with fresh water, use salt-away- coat all electrical with T9 corrosion protectant or any similar product of your choice.

GET ON THIS RIGHT AWAY - avoid the gremlin as I call it.

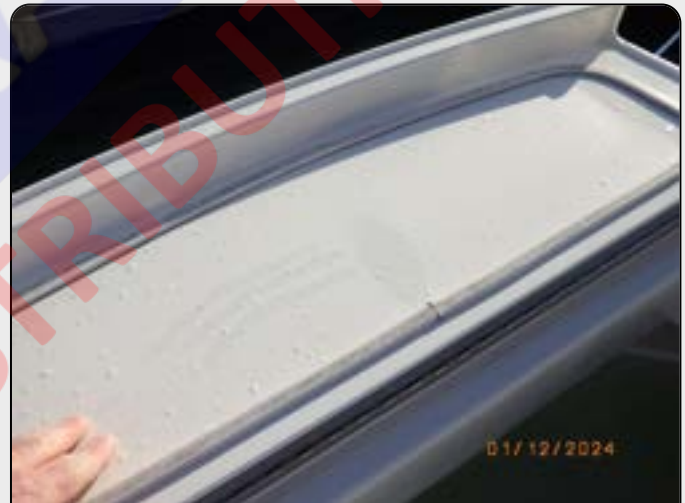
Photo 23: Common blistering of the underside top of the transom bait tank. - Moisture Cause

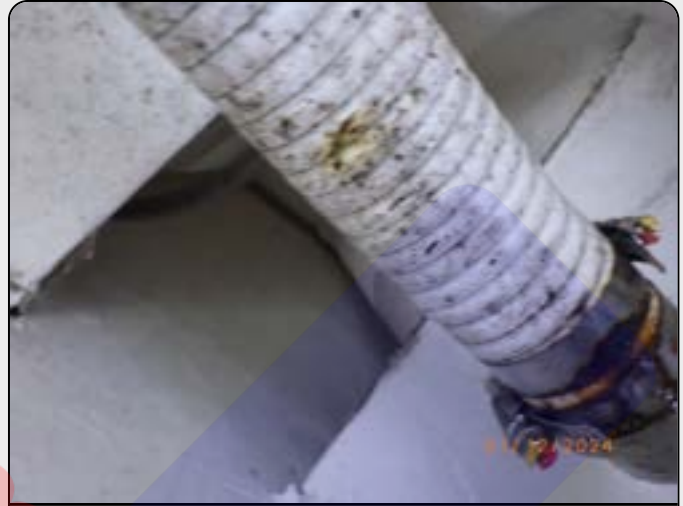
Photo 31: Leak coming from above

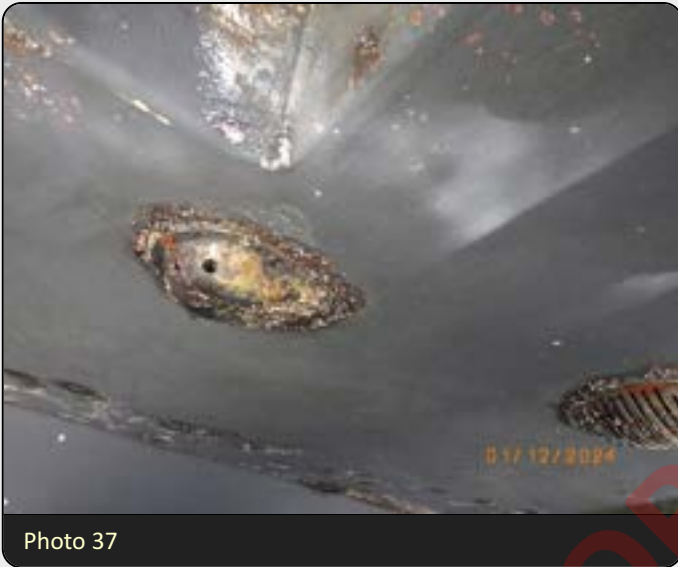
Zincs were depleted on the bow and stern

Replace the zincs with new.

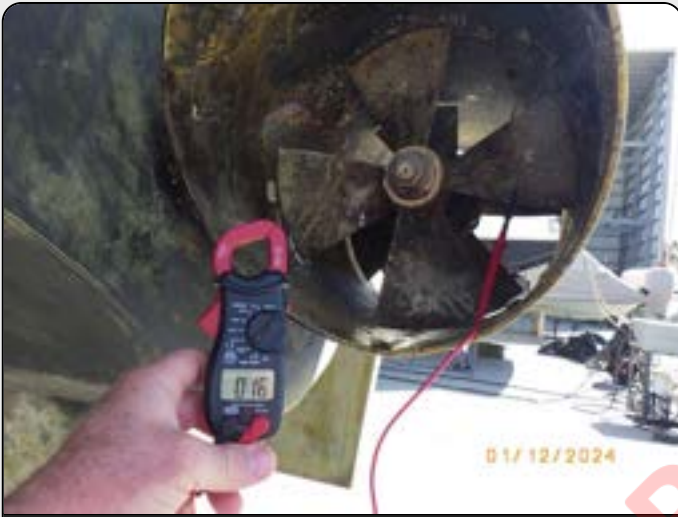
Photo 40: Continuity with transom plate

Verify connection and continuity with the main plate on the transom.

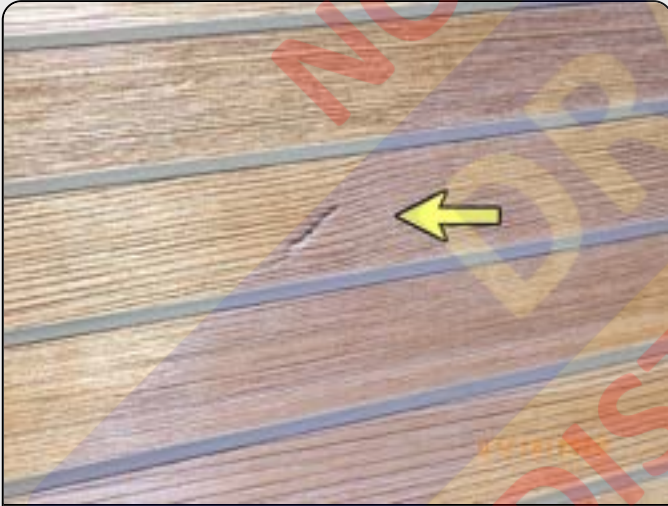
Slight wear in some areas
Marred mark noted (Located at the flybrider upper aft deck)

Photo 47: *Small marring - upper aft deck*

Repair, refinish, or replace the decks, as necessary.
