1995 54' Mediterranean Sportfisher 54

Report of Marine Survey for Insurance

George Malhiot, NAMS Associate Marine Surveyor, IIMS, USPAP Compliant Appraiser, ABYC
Ocean Marine Surveyors, Inc © 2024 - All Rights Reserved

Date Of Survey: April 4, 2024

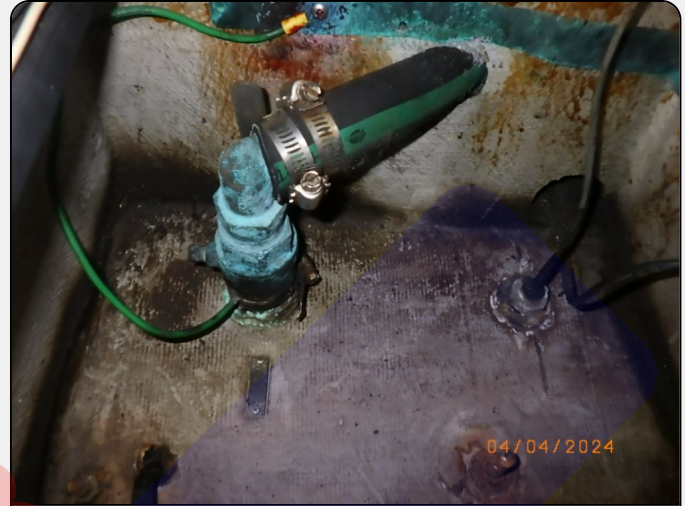
Photo 6: Engine room - no movement
