2005 57' Beneteau 57 Beneteau

"SAMPLE PREPURCHASE SAILBOAT"

Report of Marine Survey

Date Of Survey: March 11, 2024

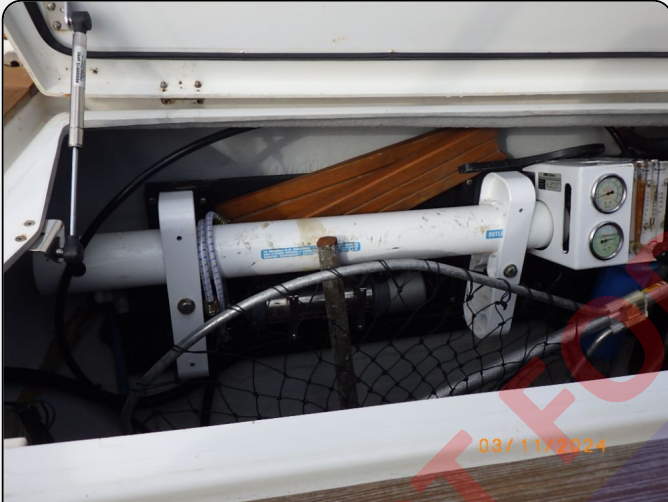
Photo 12

FINDING B-8 FRESHWATER PUMPS

RECOMMENDATION

Have the systems flushed and re-calibrated with spare filters and membranes before planned use.
Re-adjust the barbed hose fitting so not to kink the hose - Water restriction is not recommended.

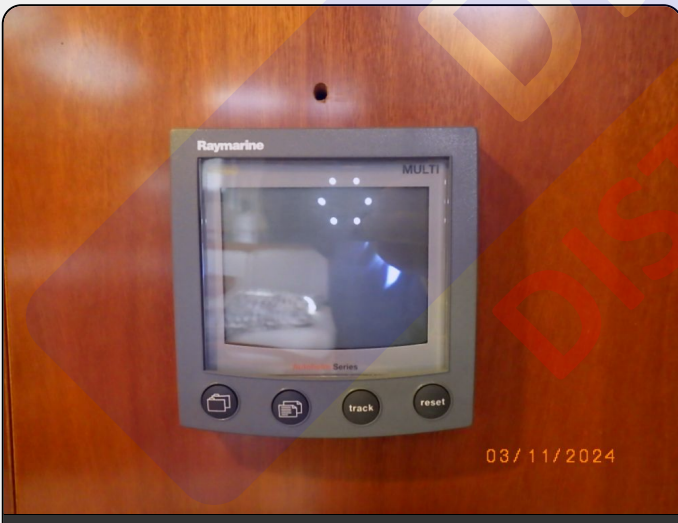
Photo 14

FINDING B-10 AUTOPILOT

RECOMMENDATION

Investigate further/trace, and service, repair or replace as necessary.

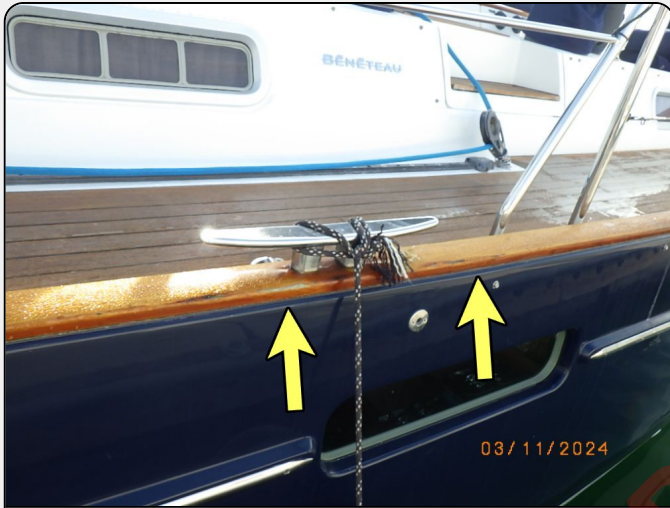
Photo 22

Some of the exterior Teak bright work varnish had slight wear or lifting.

RECOMMENDATION

Refinish the bright work as necessary.
