1995 54' Mediterranean Sportfisher 54

Report of Marine Survey for Insurance

George Malhiot, NAMS Associate Marine Surveyor, IIMS, USPAP Compliant Appraiser, ABYC
Ocean Marine Surveyors, Inc © 2024 - All Rights Reserved

Date Of Survey: April 4, 2024

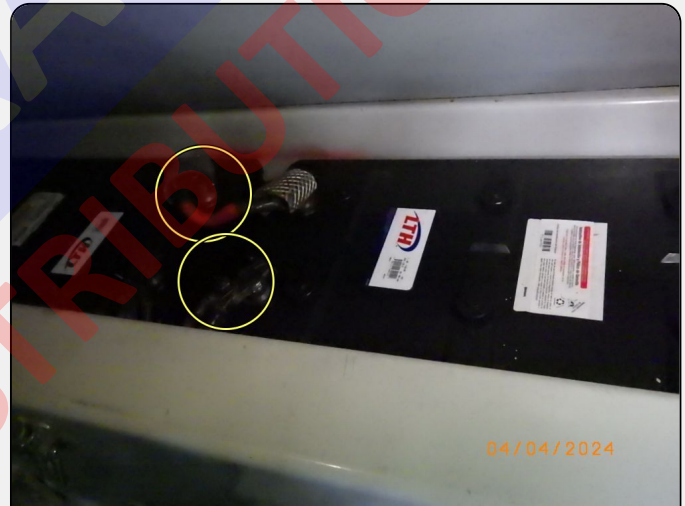
Photo 8

FINDING B-5 BATTERIES
