Pre-Purchase Report of Marine Survey

"SAMPLE PURCHASE POWER BOAT"

2022 72' Riviera Convertible Sport Fisherman 72

Date Of Survey: January 12, 2024

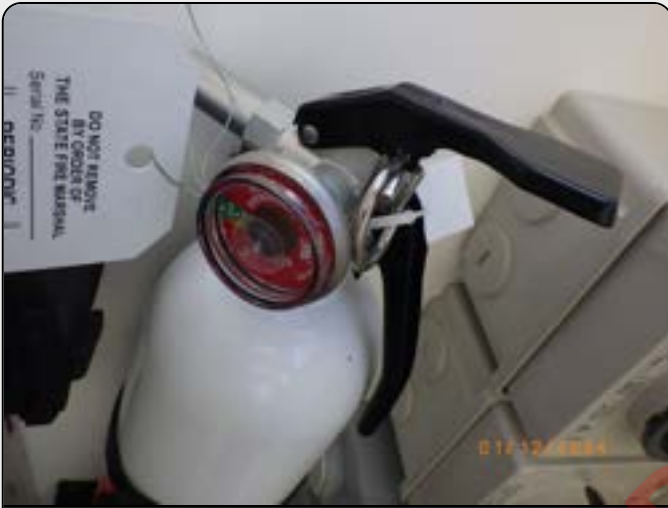
FINDING A-3 FIXED FIRE SUPPRESSION SYSTEM

Have the system re-certified in November of 2024

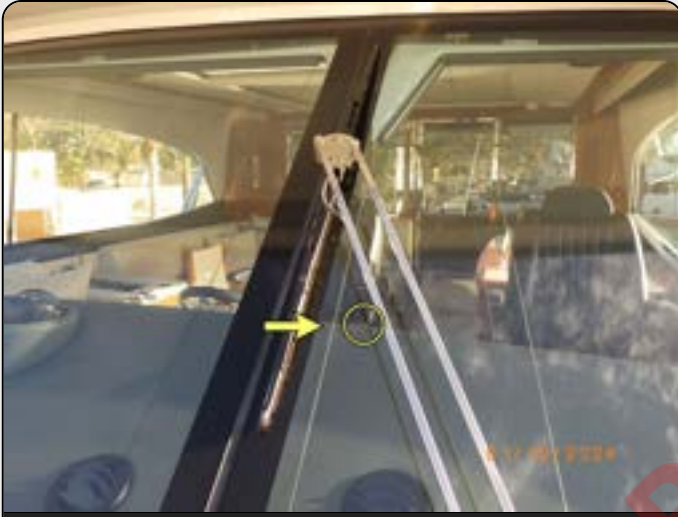
Photo 21: End of the rubber hose

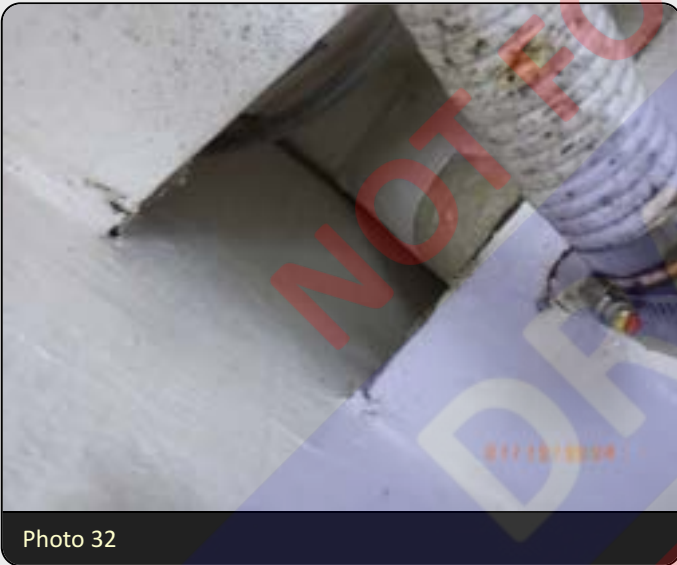
FINDING B-6 BONDING SYSTEM (ABYC E-2 & E-11)

Verify connection and continuity with the main plate on the transom.

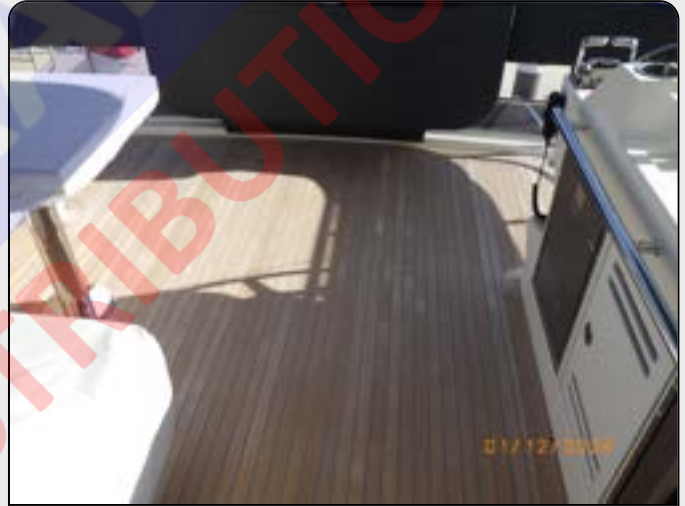
Photo 48

FINDING C-3 COCKPIT/AFT DECK EQUIPMENT
